# *Conway Gulch PAM Demonstration*

David F. Ferguson, Water Quality Resource Conservationist with the Idaho Soil Conservation Commission  
October 29, 1997

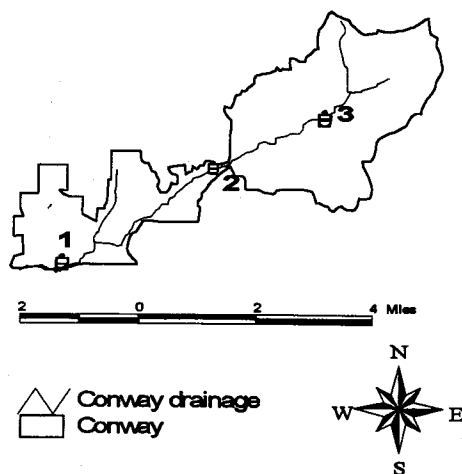
## Monitoring sites

During the two weeks that PAM was applied by various means on surface irrigated fields, the Idaho Department of Agriculture monitored the gulch at three locations in the drain. Water monitoring occurred at each location at least 4 times a day. The individual samples were then shipped that same day for analysis. The monitoring station locations were the same the locations used by the Division of Environmental Quality in past monitoring so that a comparison could be made to past monitoring data. Chemical and physical parameters monitored were flow, suspended sediment, phosphorus, nitrogen, dissolved oxygen, temperature, conductivity, dissolved solids, and pH. This drain monitoring occurred on June 10, 17, 19, 24, and 26.

The ARS took samples on the June 12, 17, and 19 from the drain at each monitoring location and centrifuged the samples at the Black Canyon Irrigation District facilities. They were then analyzed for PAM at the Kimberly ARS center later. The SCC and the NRCS staff checked field runoff for flow, sediment, nutrients and PAM. Flow rates were taken at all field culverts entering the gulch along its entire length. Most of the field culvert locations were known because of the work done in the area through previous farm conservation work. Landowners also supplied additional information about any culverts hidden by vegetation and drain banks.

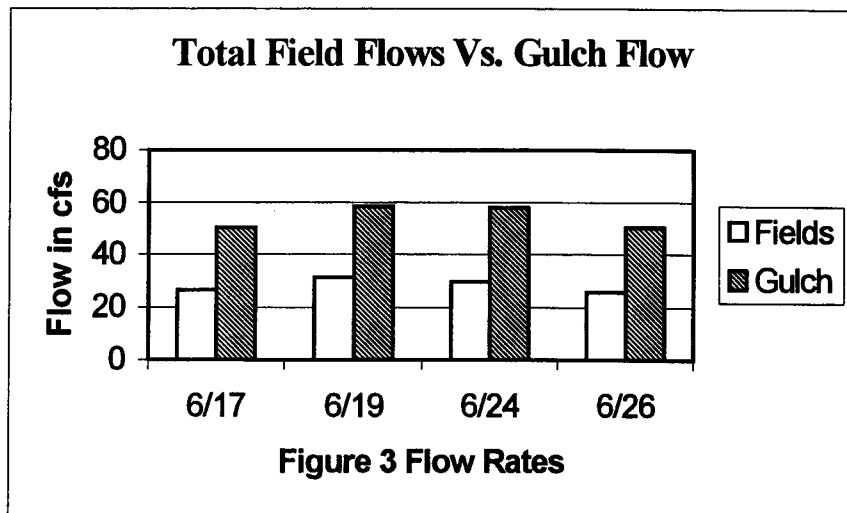
Problems encountered during the demonstration were few, but getting a clear picture of total drain inflow was difficult. The five-gallon bucket and stop watch were the most appropriate tools for determining field outflows at most sites except ten. Flow rates at these ten sites were estimated. All measured and estimated flow rates were subtracted out of the drain flow rates to quantify ground water contributions. One half of the flow seemed to come from ground water recharge as shown in.

Ground water contributions seem large, possibly contributing half of the total outflow in Conway Gulch during the month of June. Additional studies need to be done to determine actual ground water contributions throughout the year
